REPORT OF SAMPLING ACTIVITIES

RICO-ARGENTINE MINE

RICO, COLORADO

TDD R8-8411-02

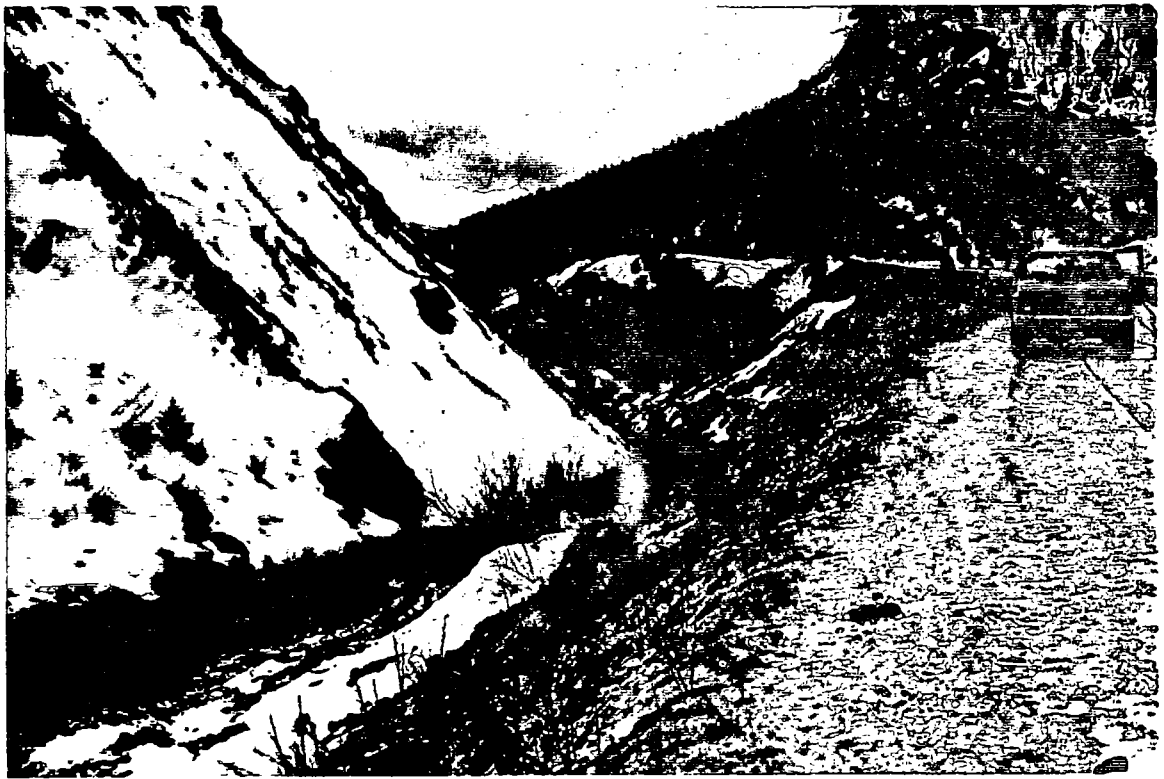
PHOTO 1: LOCATION OF UPGRADIENT SURFACE WATER SAMPLE, RA-SW-5, ON THE DOLORES RIVER. VIEW IS TO THE SOUTH. HORSE CREEK IS APPROXIMATELY $\frac{1}{2}$ MILE TO THE SOUTH.

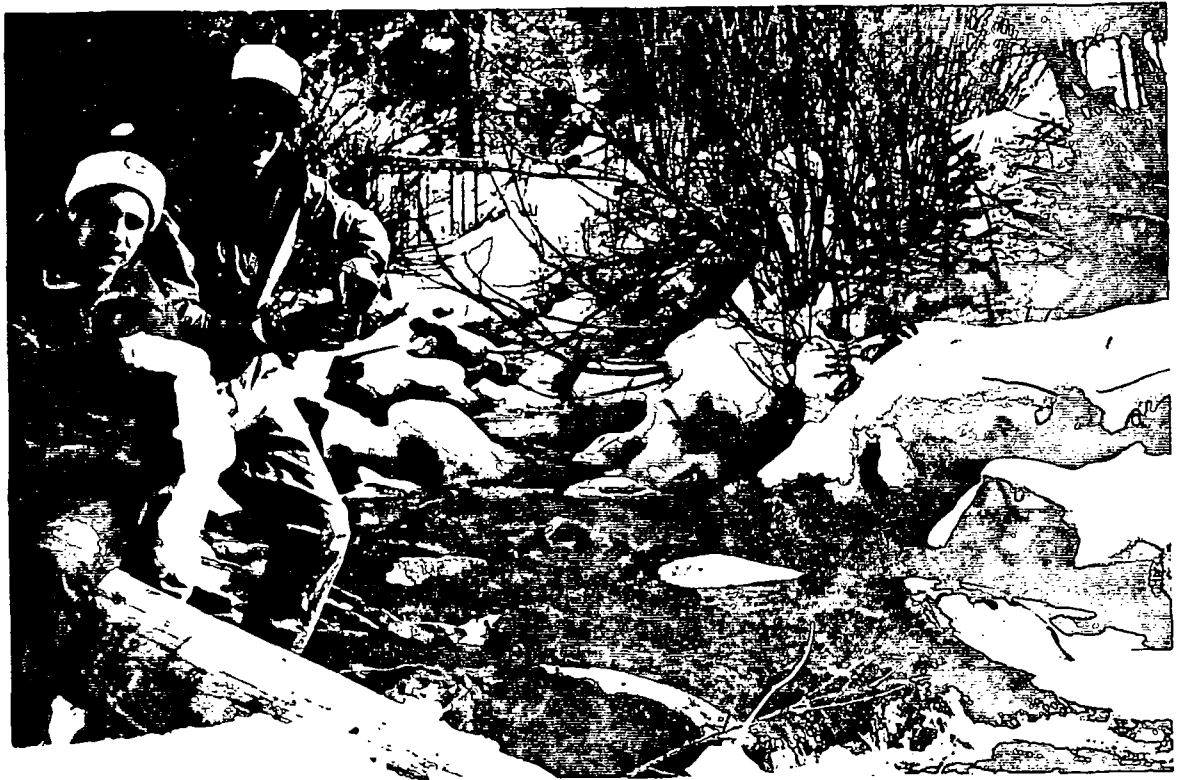
PHOTO 5: (ABOVE) LOCATION OF
UPSTREAM SURFACE WATER
SAMPLE RA-SW-1 ON SILVER
CREEK. GREEN BUILDING
IN BACKGROUND NOTES
LOCATION OF TOWN WATER
SUPPLY.

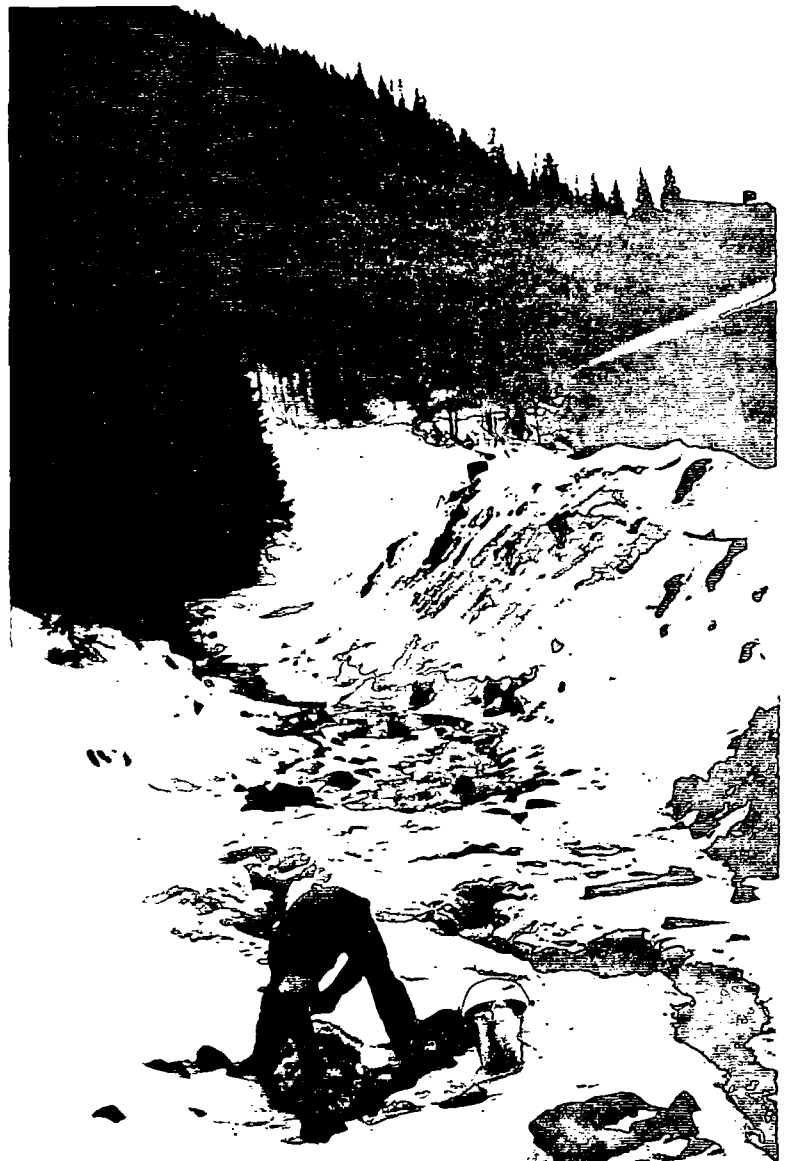
- o The Blaine Tunnel, which is not permitted for discharge, was observed to be discharging into Silver Creek. The discharge appeared heavier in the October, 1984 site visit but was still flowing moderately during the sampling activity.

PHOTO 6: (RIGHT) LOCATION OF
SURFACE WATER SAMPLE
RA-SW-2 TAKEN DOWN-
STREAM OF BLAINE
TUNNEL DISCHARGE ON
SILVER CREEK.

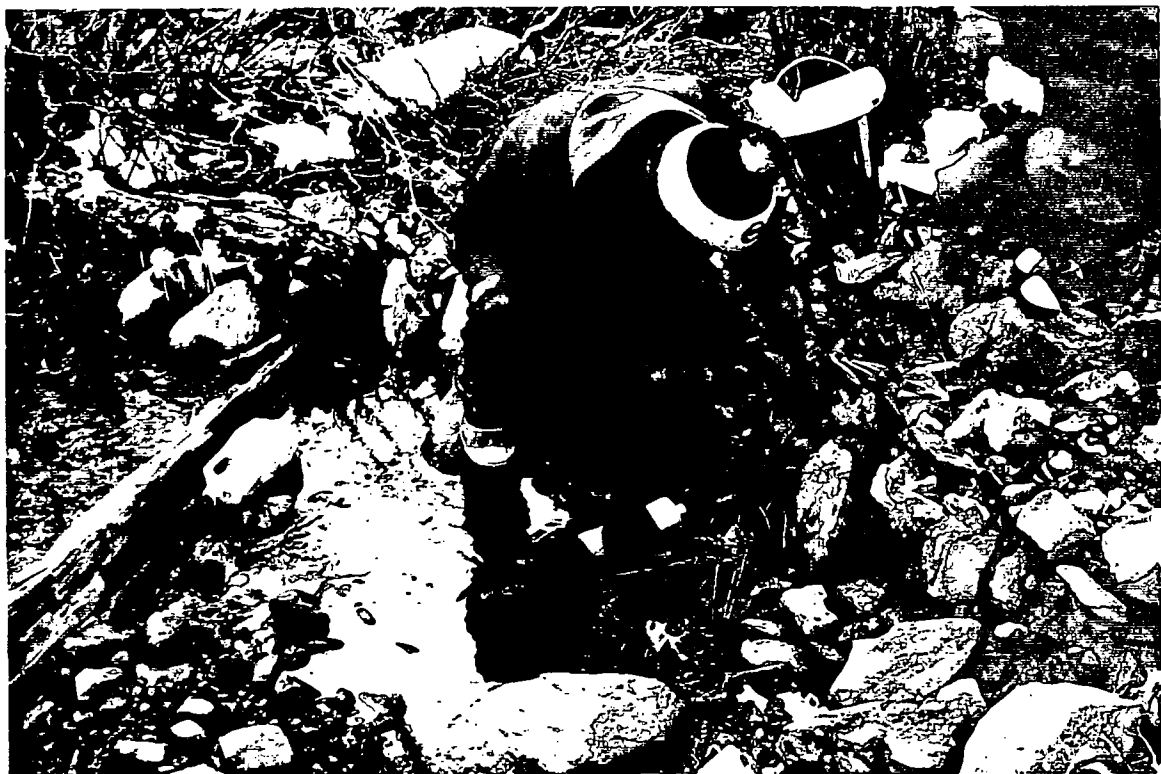
PHOTO 8: (BELOW) LOCATION OF
SURFACE WATER SEEP
SAMPLES RA-SW-4 AND
RA-SW-10 SHOWING
CLOSE-UP OF IRON
STAINING.

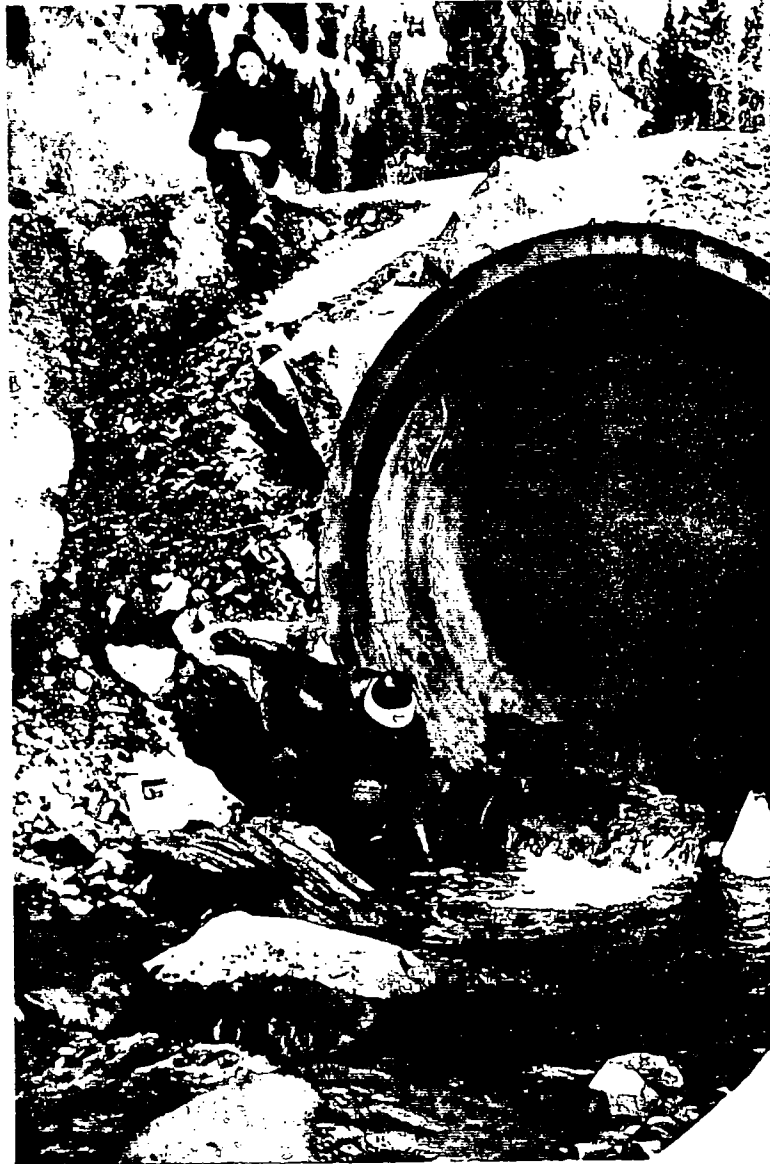
PHOTO 9: LOCATION OF SURFACE WATER SAMPLE RA-SW-3
TAKEN DOWNSTREAM OF TAILINGS PONDS ON
SILVER CREEK.
